# MOTOR VEHICLE INSPECTION REPORT

**2014 NISSAN PULSAR ST  
C12**

Inspection Details	
Inspection Reference	996263
Name of Inspector	Shal Singh
Mobile	0415267099
Inspection Date	4/03/2023
Inspection Address	22/151 Hartley Rd Smeaton Grange NSW 2567

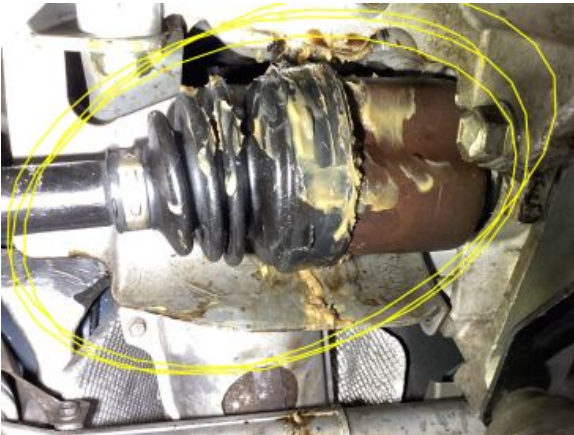
- 57 Drive Shafts & CV Joints - Drivers side CV joint leaking grease as per photos attached. CV boot retaining clip is missing.
- 58 Front & Rear Suspension - Drivers side suspension control-arm bent as per photos attached.

drivers side CV shaft boot leaking grease

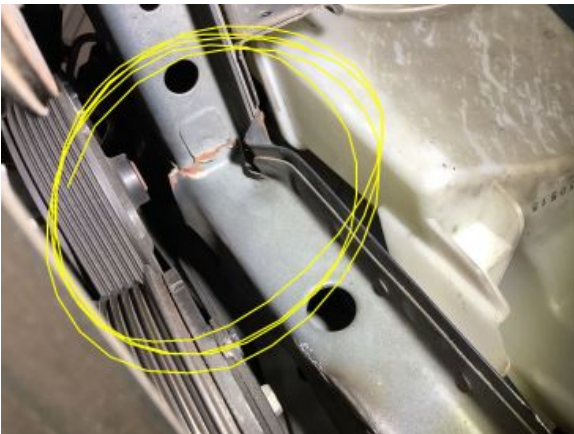
- 2 Horn - Horn inoperative.  
Repairs highly recommended for roadworthiness
- 4 Seat Belts - Right rear seat-belt does not retract.
- 27 Under Body Panels - Drivers side chassis and support beam bent/kinked as per photos attached. Consistent with front-end collision damage.  
Unroadworthy.

drivers side chassis bent/kinked

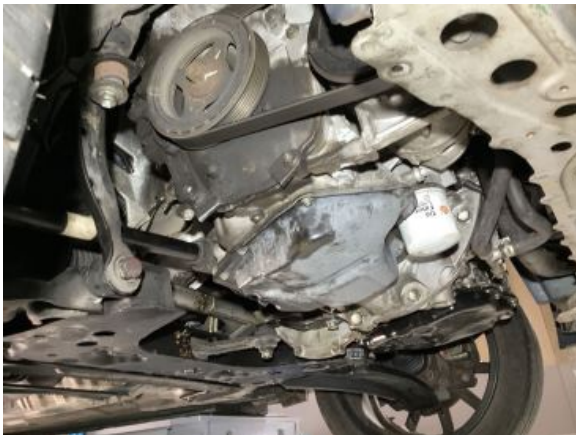
- 64 Others - Several underbody splash trays/stone guards are either missing or badly damaged.
- 66 Wheel Rims - Right front wheel nut missing x 1 as per photos attached.

stone guards/splash tray missing underbody

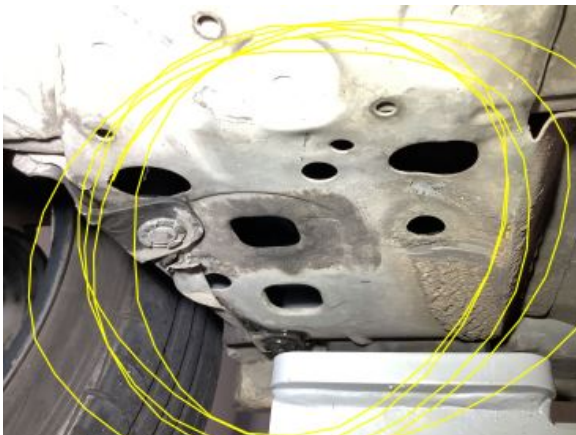
drivers side underbody support beam bent

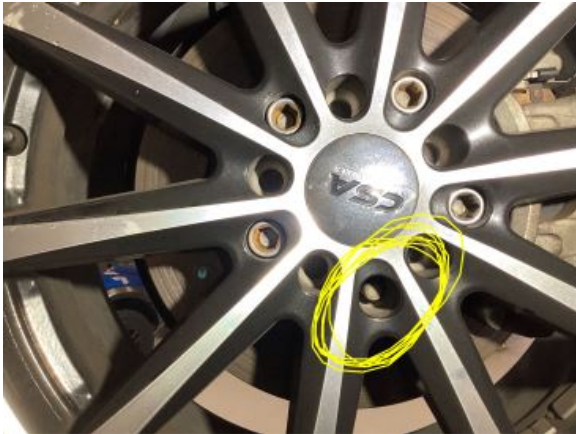
right front wheel nut missing

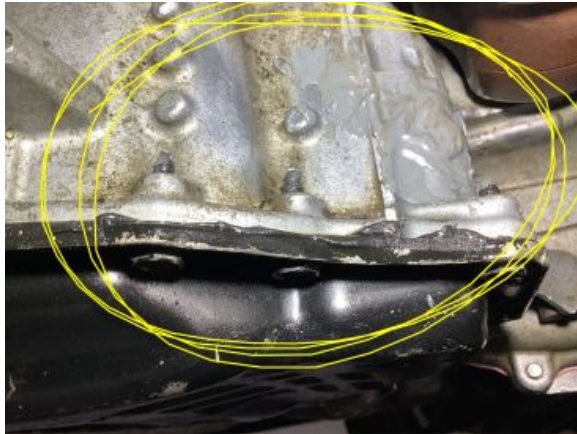
- 54 Auto / Manual Gearbox - Auto-transmission casing is repaired with silicon as per photos attached. Auto-transmission may have been damaged prior to sub-standard repairs by external force then repaired with silicon.  
Transmission oil leak (heavy) is evident at repaired area of casing.

auto transmission case repaired with silicon/leaking

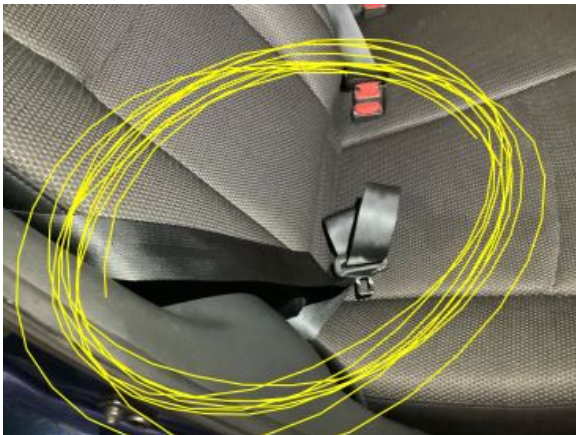
right rear seat belt does not retract

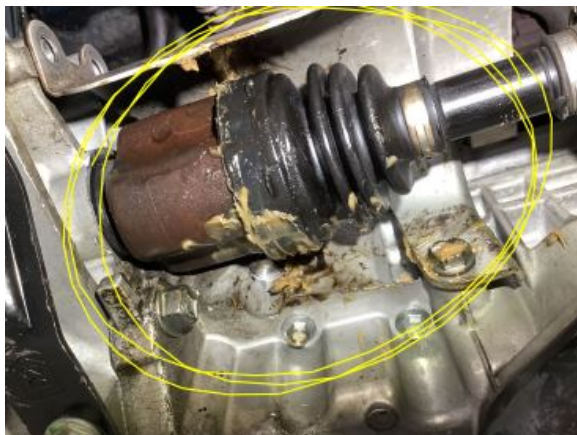
grease splashed out from Cv boot

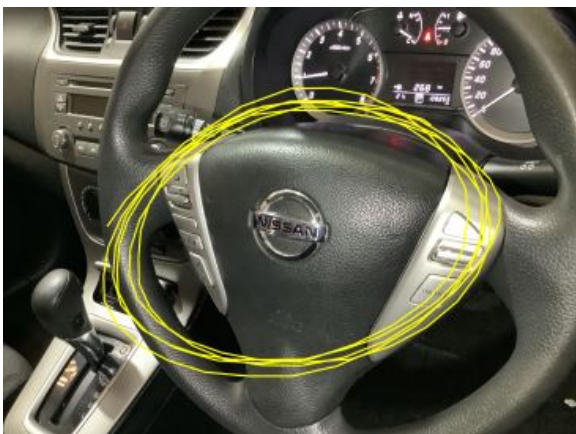
horn inoperative
