# MOTOR VEHICLE INSPECTION REPORT

**2014 NISSAN PULSAR ST  
C12**

Inspection Details	
Inspection Reference	996263
Name of Inspector	Shal Singh
Mobile	0415267099
Inspection Date	4/03/2023
Inspection Address	22/151 Hartley Rd Smeaton Grange NSW 2567

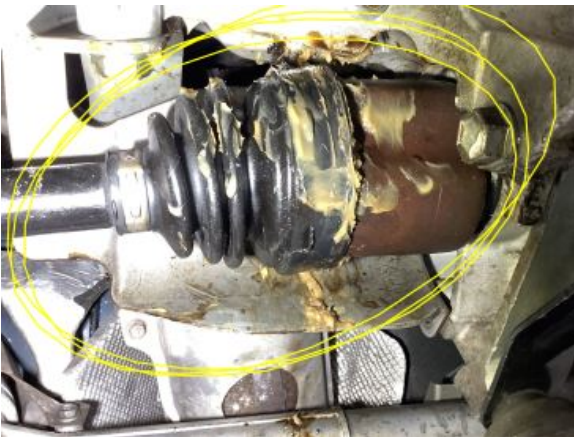
- 57 Drive Shafts & CV Joints - Drivers side CV joint leaking grease as per photos attached. CV boot retaining clip is missing.
- 58 Front & Rear Suspension - Drivers side suspension control-arm bent as per photos attached.

drivers side CV shaft boot leaking grease

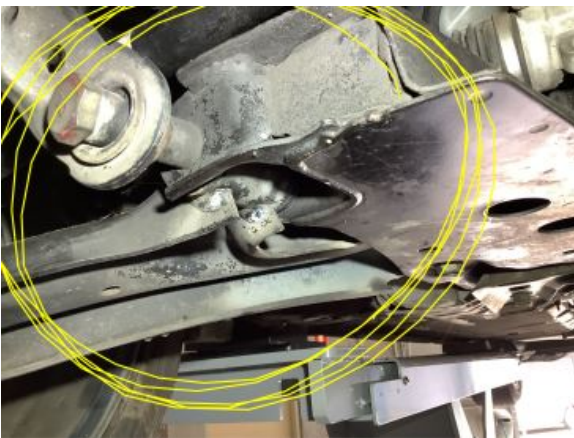
drivers side control arm bent

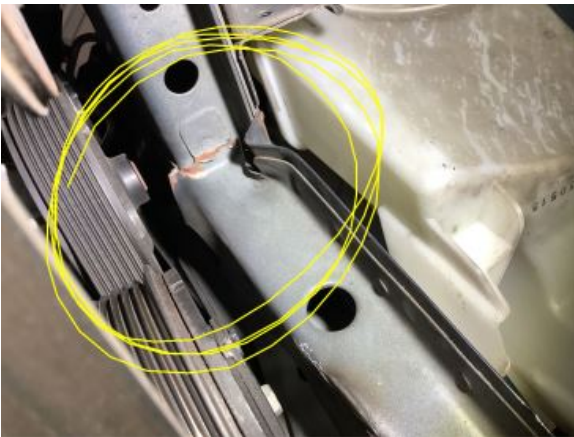
- 2 Horn - Horn inoperative.  
Repairs highly recommended for roadworthiness
- 4 Seat Belts - Right rear seat-belt does not retract.
- 27 Under Body Panels - Drivers side chassis and support beam bent/kinked as per photos attached. Consistent with front-end collision damage.  
Unroadworthy.

drivers side chassis bent/kinked

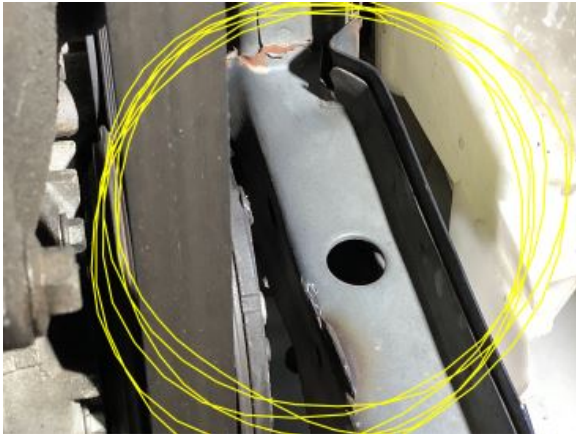
drivers side chassis bent

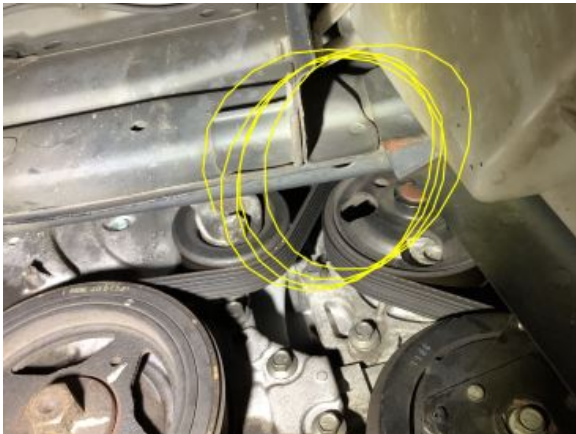
drivers side chassis bent

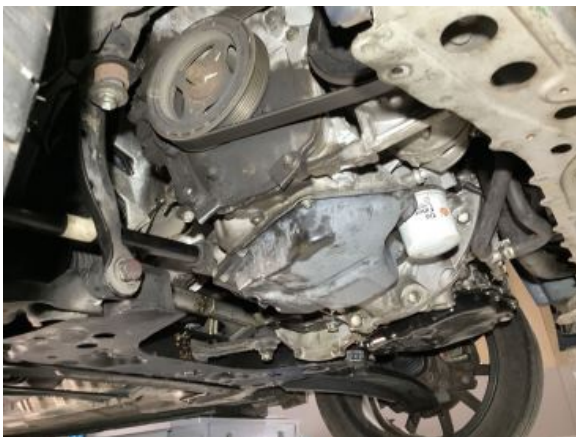
- 64 Others - Several underbody splash trays/stone guards are either missing or badly damaged.
- 66 Wheel Rims - Right front wheel nut missing x 1 as per photos attached.

stone guards/splash tray missing underbody

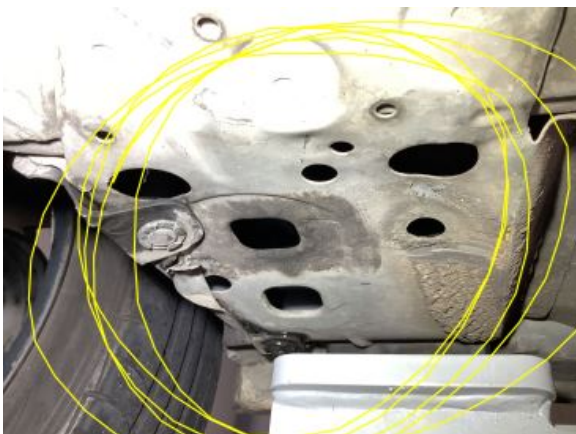
drivers side underbody support beam bent

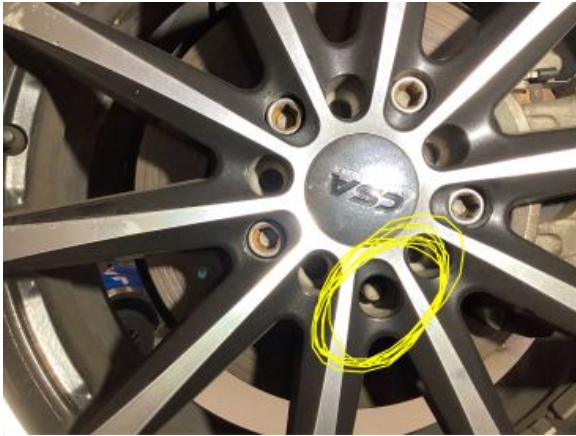
right front wheel nut missing

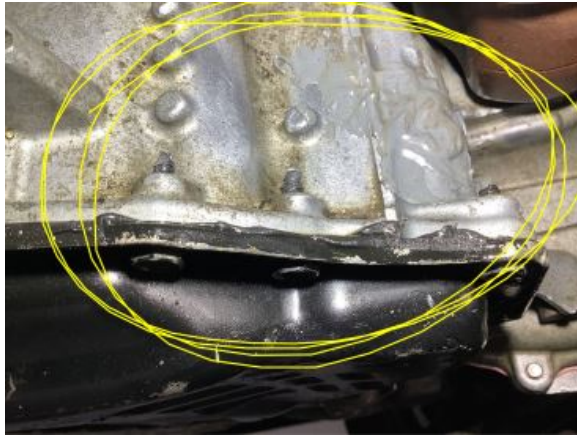
- 54 Auto / Manual Gearbox - Auto-transmission casing is repaired with silicon as per photos attached. Auto-transmission may have been damaged prior to sub-standard repairs by external force then repaired with silicon.  
Transmission oil leak (heavy) is evident at repaired area of casing.

auto transmission case repaired with silicon/leaking

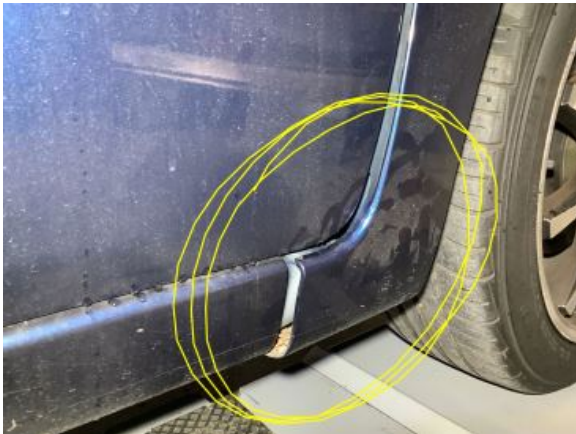
- 25 Body - Sub-standard paint and panel repairs noted at front body panels.  
Uneven gaps between panels indicate body misalignment.

uneven gaps between panels

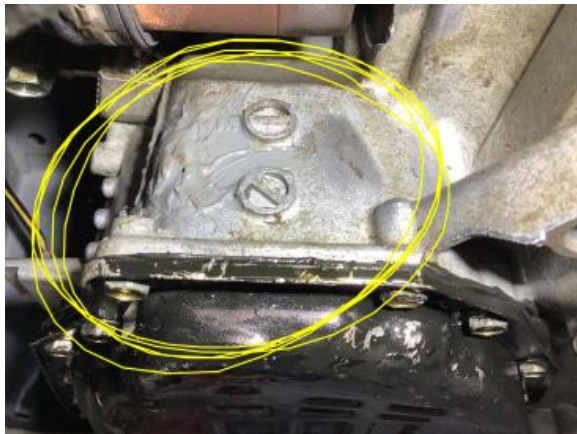
auto transmission case repaired with silicon

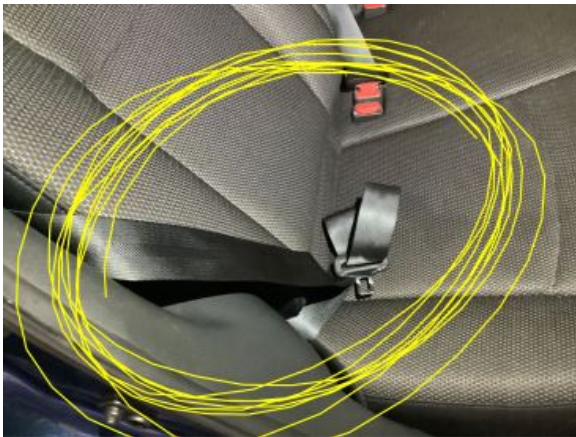
right rear seat belt does not retract

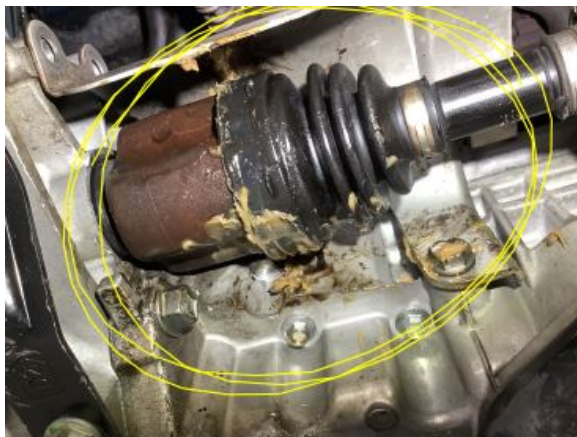
grease splashed out from Cv boot

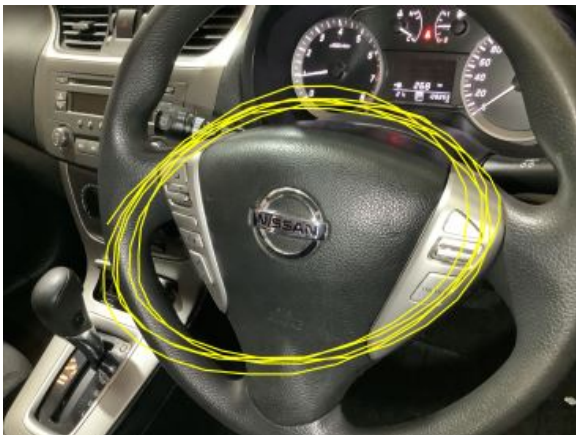
horn inoperative
