# MOTOR VEHICLE INSPECTION REPORT

**2014 NISSAN PULSAR ST  
C12**

Inspection Details	
Inspection Reference	996263
Name of Inspector	Shal Singh
Mobile	0415267099
Inspection Date	4/03/2023
Inspection Address	22/151 Hartley Rd Smeaton Grange NSW 2567

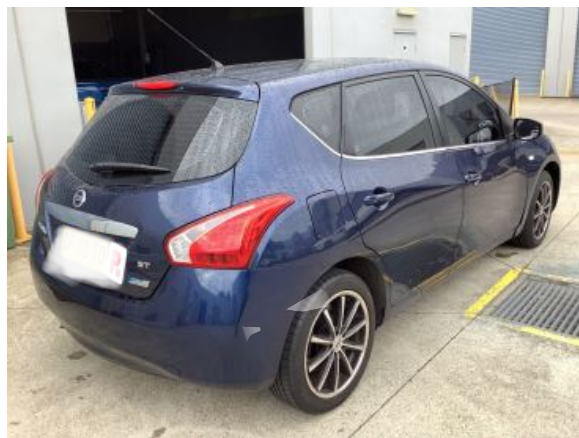
- 57 Drive Shafts & CV Joints - Drivers side CV joint leaking grease as per photos attached. CV boot retaining clip is missing.
- 58 Front & Rear Suspension - Drivers side suspension control-arm bent as per photos attached.

drivers side control arm bent

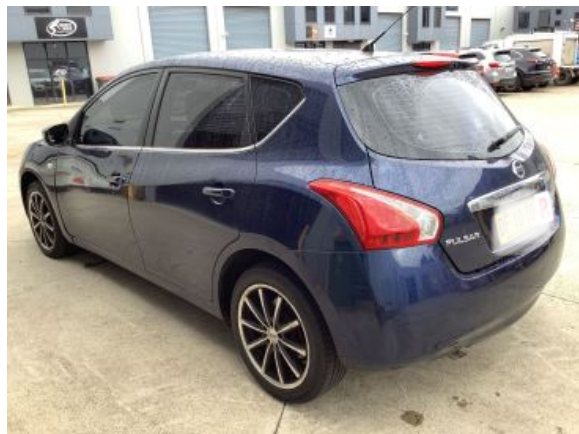
- 2 Horn - Horn inoperative.  
Repairs highly recommended for roadworthiness
- 4 Seat Belts - Right rear seat-belt does not retract.
- 27 Under Body Panels - Drivers side chassis and support beam bent/kinked as per photos attached. Consistent with front-end collision damage.  
Unroadworthy.

drivers side chassis bent/kinked

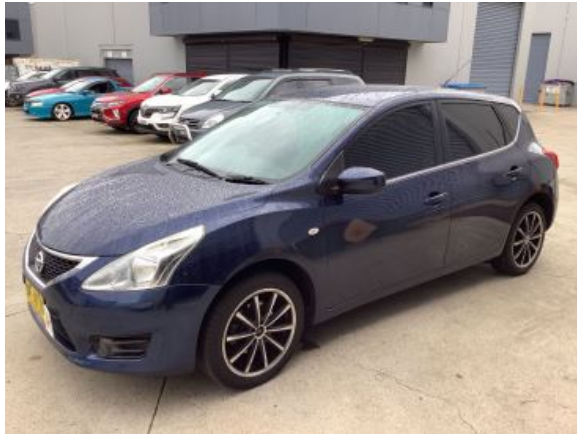
drivers side chassis bent
